Manhole Inspection Summary

Manhole # S27CC_033MH

Insp Date: **4/21/09 12:15 PM**

Location Address: **1401 PENN**

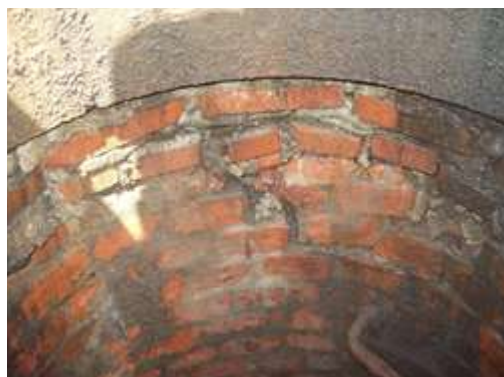
Defect 2

Condition: ☐ Sound ☒ **Cracked** ☐ Root Intrusion ☐ Loose Brick ☐ Deteriorated

Steps Count: **6** Missing: **0** ☒ **Corroded**

STEPS CORRODED/CRACKED
CHIMNEY

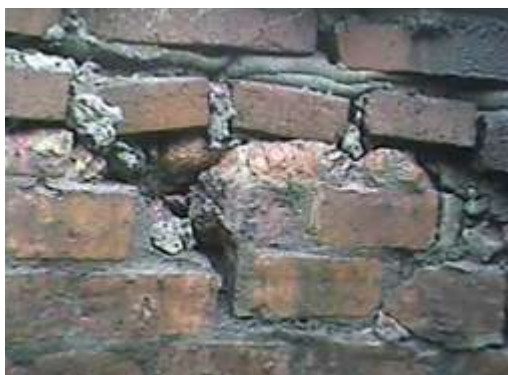
Defect 1

Condition: ☐ Sound ☒ **Cracked** ☐ Root Intrusion ☐ Loose Brick ☐ Deteriorated

CRACKED CORBEL

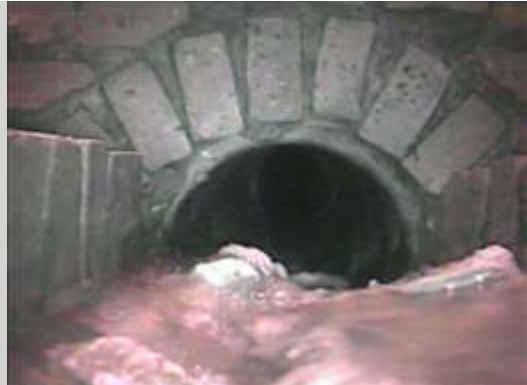
12 O'Clock Outflow

10 in. Circular Gravity Sewer
Pipe Out @ 12 O'Clock

Pipe Height: (in.) Direct
Pipe Material: **Clay** ☐ Pipe Lined
Invert Depth: **11.22** (ft.) Flow Characteristics: **Slow**
Deposits: ☐ None ☐ Mud ☐ Sludge ☒ **Debris** ☒ **Grease**
Silt Depth: **3** (in.) Deposits Extent: **Medium**
Infiltration: **None** Pipe Seal Cond: **Sound**

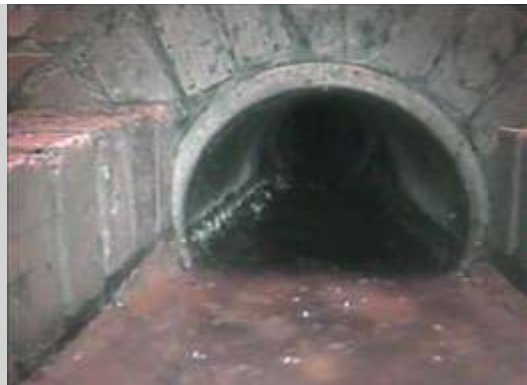
5 O'Clock Inflow

10 in. Circular Gravity Sewer
Pipe In @ 5 O'Clock

Pipe Height: (in.) Direct
Pipe Material: **Clay** ☐ Pipe Lined
Invert Depth: **11.06** (ft.) Flow Characteristics: **Slow**
Deposits: ☐ None ☐ Mud ☐ Sludge ☒ **Debris** ☐ Grease
Silt Depth: **2** (in.) Deposits Extent: **Medium**
Infiltration: **None** Pipe Seal Cond: **Sound**
